the other side of the coin.

HIGH-TECH SYSTEMS

On-site sorting machine

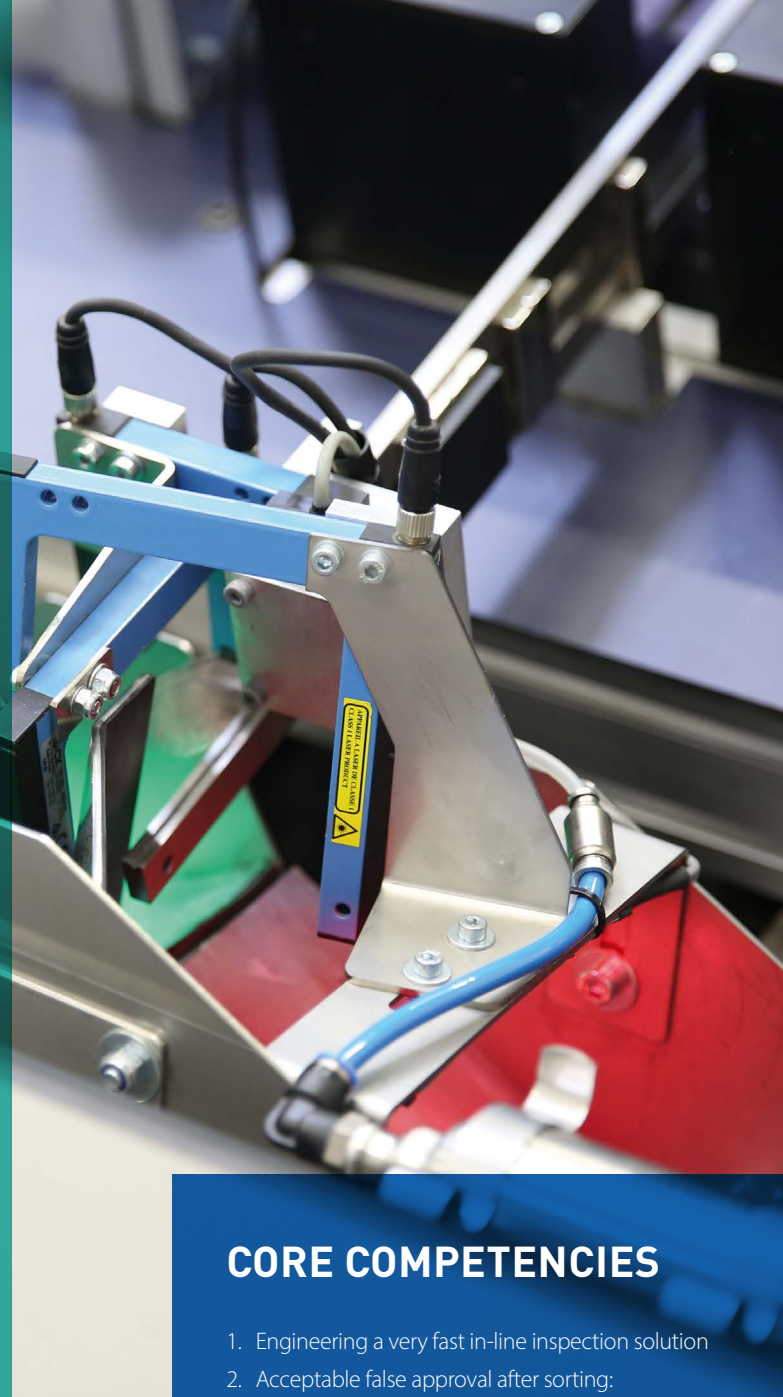
The time pressure was unbelievable. The engineering team worked day and night to get a system up and running. Starting point was a mechanical coin separator provided by the customer. It enabled presenting the coins to the actual inspection system one by one. This heart of the system was made from of-the-shelf components.

Visual inspection of the coin took place when the coins were in free fall. Each coin was photographed from both sides simultaneously and the picture analysis was the basis for the decision 'accept' or 'reject'. This decision making process literally took place in a split second: six coins passed along the vision system per second. When accepted they were blown off on a conveyor-belt, when rejected they landed in a container underneath. This order may sound counter-intuitive, but minimises the risk of false positives (rejected coins landing between the accepted coins).

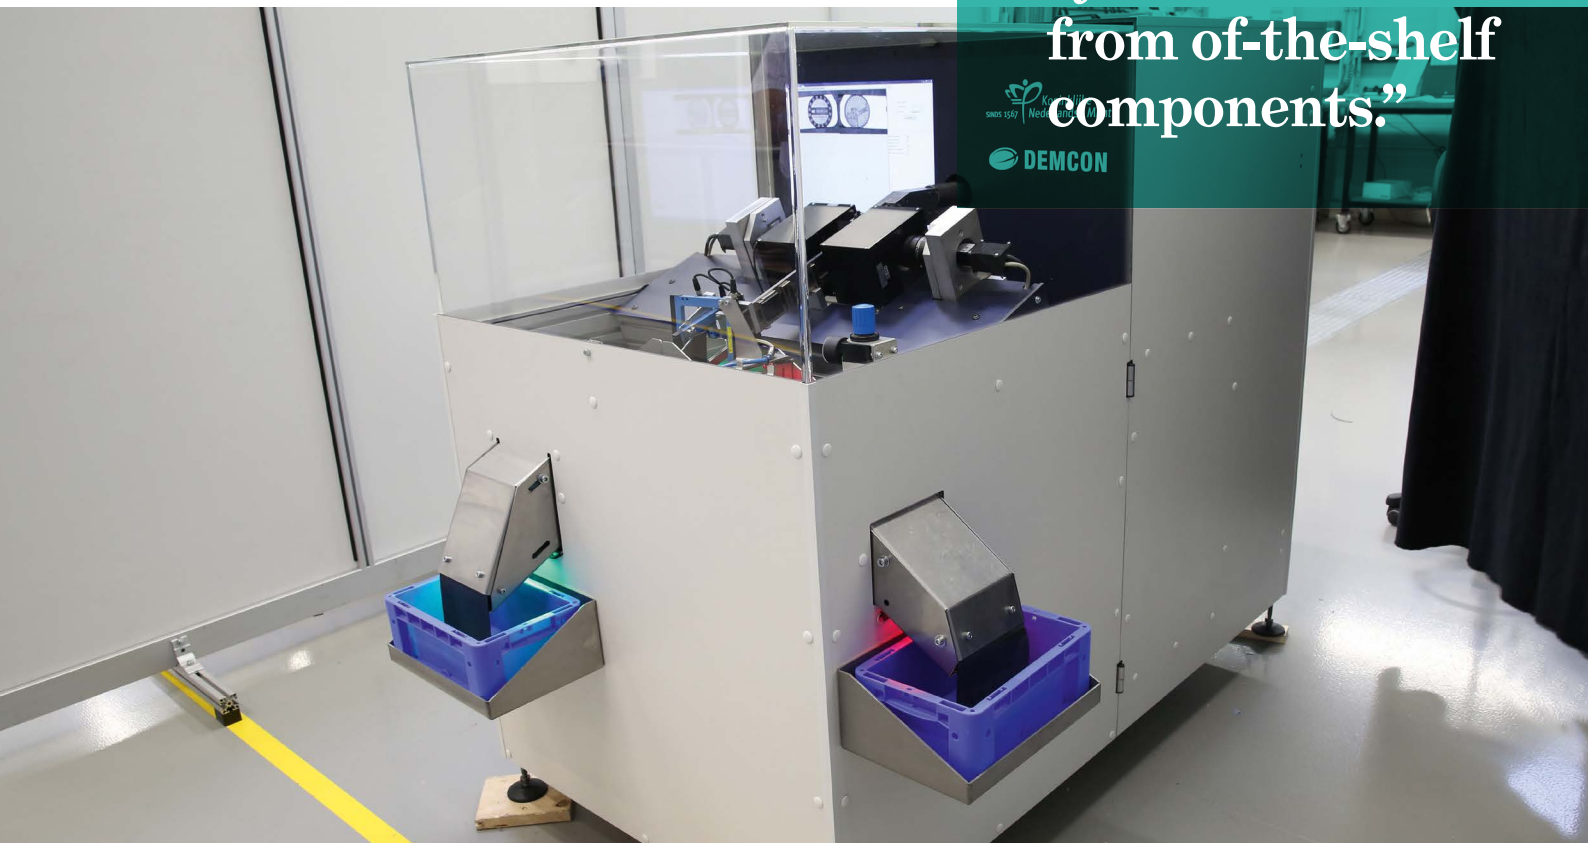
“the heart of the system was made from of-the-shelf components.”
